HIGHWAY RESEARCH RECORD

Number | Design of
346 | Sign Supports and Structures

HIGHWAY RESEARCH BOARD

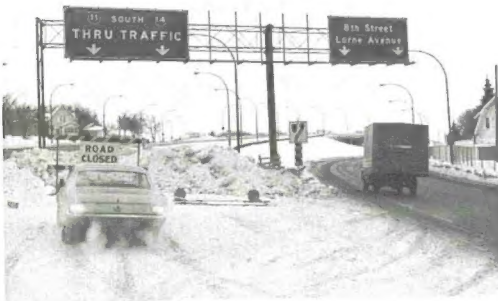
Figure 1. "Old style" overhead sign structure.

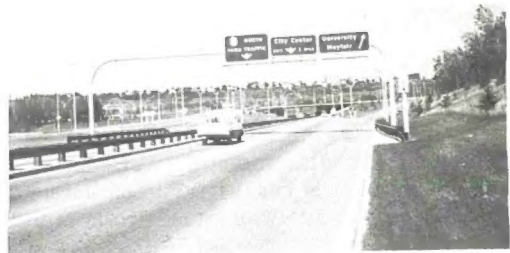
Figure 2. "New style" overhead sign structure (85-ft span; 14-in. pipe diameter).

The truss configuration was, at one time, almost a universal choice for all but very short-span highway bridges. It became recognized that this type of structure was not aesthetically pleasing. The modern welded girder and prestressed concrete long-span structures were developed to replace the truss. The resulting structures were more slender and presented a solid profile. Deflection and span-depth-ratio limitations continue in most present day highway bridge design specifications as an impediment to further improvement. These rules are rather arbitrary and, while they may have served suitably in the past, it is now recognized that relaxation is possible by means of more liberal regulations (2). Similar changes can be applied to overhead sign structures resulting in greater simplicity and improved appearance. An example of where this has been done is shown in Figure 2.

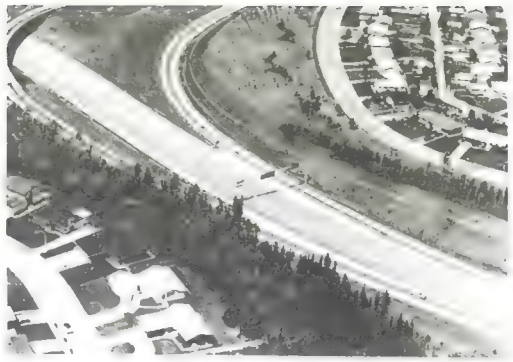
Figure 3. Long span provides clear gore area and flexibility of structure location (140-ft span; 20-in. pipe diameter).

New highway safety practices (3) require the elimination of hazardous fixed objects from the roadside. Where this is impractical, adequate protective barriers are to be used. Overhead sign supports are not to be located in the gore area. Such structures are required to span the ramp exit pavement as well as the through lanes. Where flexible barriers are used, the location of overhead sign supports in narrow medians is undesirable, and spans clearing the roadways for both directions of traffic are necessary. Under these circumstances spans as long as 200 ft may be required to clear as many as 10 lanes of divided traffic and exit pavement, with adequate safe outside shoulder clearance, and capable of supporting up to four full-size freeway signs. The use of long-span monotubular sign structures as reported herein, allows these new highway safety practices to be met (Fig. 3).

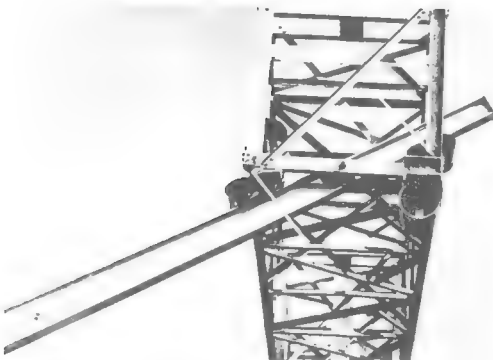
Figure 3. Detail of OSB impact attenuator device.

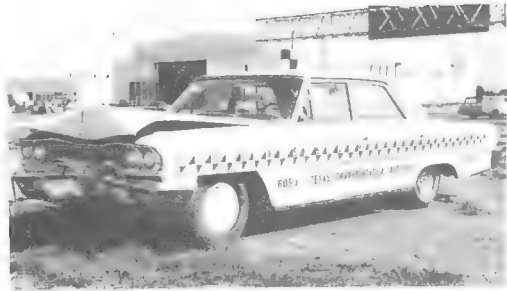
Figure 3. Vehicle after Test A.

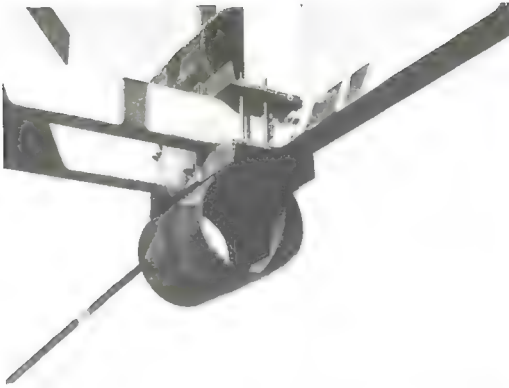
Figure 6. Load distributor bolted in place on lower truss chord at support A.

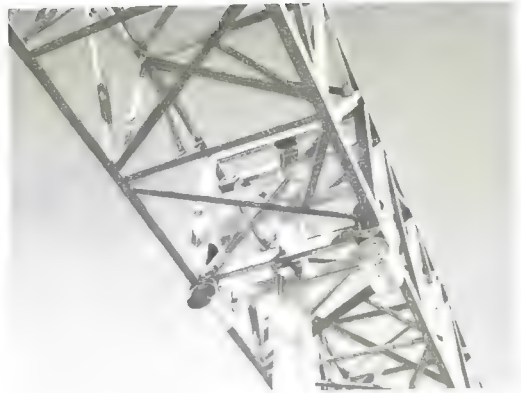
Figure 7. Load distributors at support B before Test B.

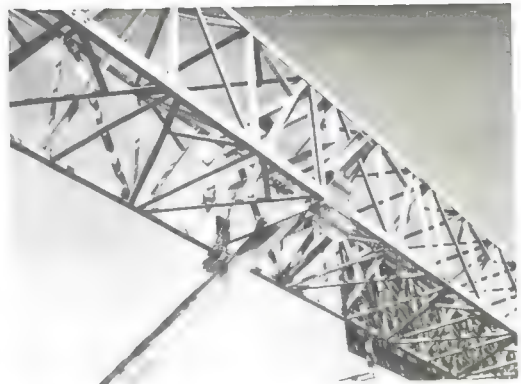
Figure 8. Load distributor at support B after Test B.

To provide the required distribution and dissipation a steel-tube load distributor was designed which could be placed to protect the lower chord members of the truss. Static laboratory and field tests were run to verify the function of these distributors before crash tests were conducted. A close-up of the load distributor before it was placed on the truss is shown in Figure 5, and typical installations on the truss are shown in Figures 6 and 7. Selection of the channel sections was made (a) to provide adequate load distribution to the truss, and (b) to provide a flat bearing surface for the cylindrical tubes during impact loading. The design of the connection provided both conditions, as can be seen in Figure 8. No damage to the lower chord occurred

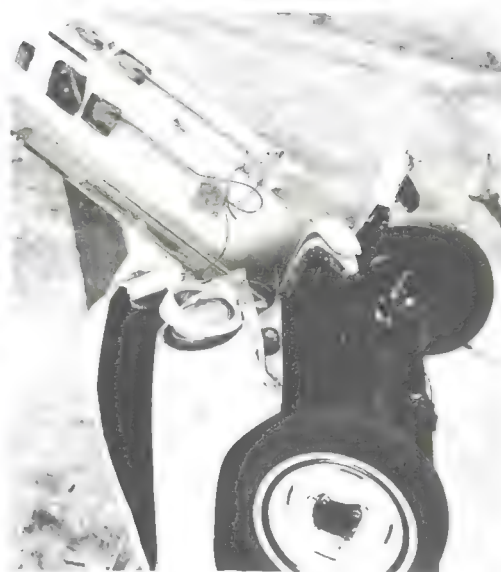
Figure 10. Vehicle wedged between support and ground (Test B).

Close-up views of the front end of the car are shown in Figures 10 and 11. Examination of data from accelerometers indicated that the average deceleration was 9.6 g over 0.068 second. The peak deceleration was 22.4 g occurring at ap-

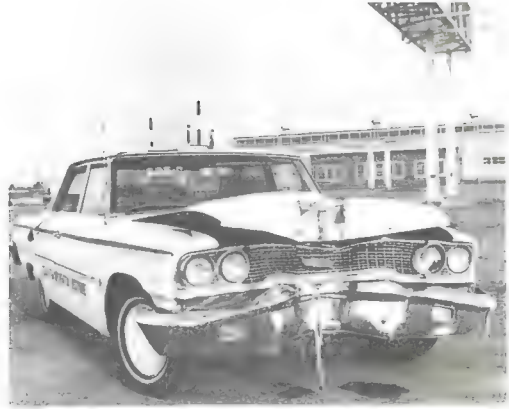
Figure 12. Vehicle after Test C.

The average vehicle deceleration was determined to be 6.7 g over 0.064 second, and a peak deceleration of 19.1 g, occurring at $t = 0.050$ second, was observed on the accelerometer trace. The vehicle's speed was reduced 8.9 mph by the collision. Damage to the vehicle is shown in Figure 12.

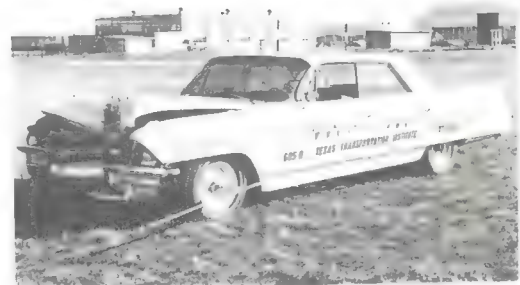
Figure 14. Vehicle after Test D.

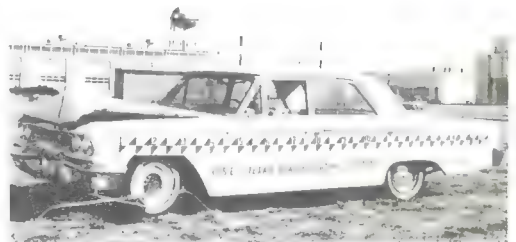
Figure 16. Vehicle after Test E.

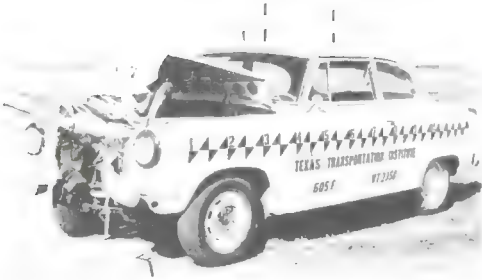
Figure 17. Vehicle after Test F.

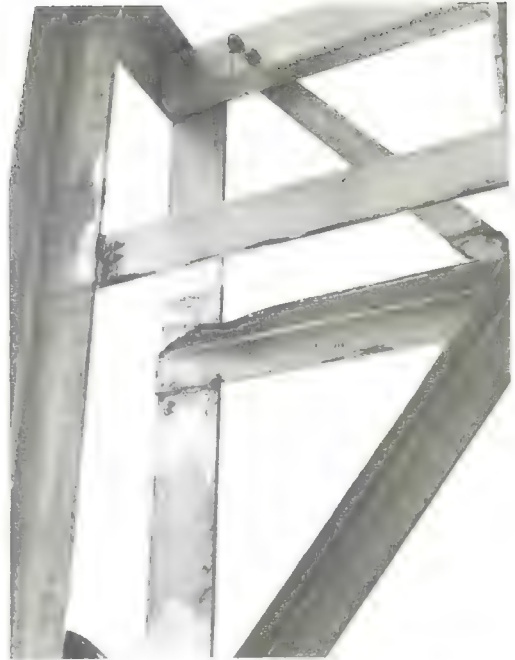
Figure 18. Damage to truss guide angle (Test F).

The truss twisted through 8 deg and the upper connection bolts at support B were fractured. Upper connection bolts at sup-

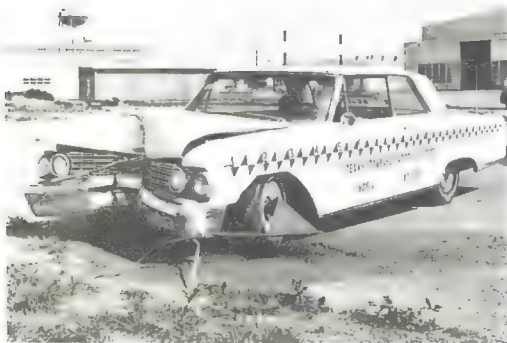
Figure 21. Vehicle after Test G.

A Ford weighing 3,950 lb collided with support A at 50.1 mph and an impact angle of 15 deg. The vehicle was slowed 10.2 mph as a result of the collision. The average decelerative unit force on the vehicle was 5.8 g, and the peak decelerations were observed to be 15.3 g (longitudinal) and 3.5 g (transverse). These peaks occurred at approximately 0.040 second after impact. Damage to the crash vehicle is shown in Figure 21.

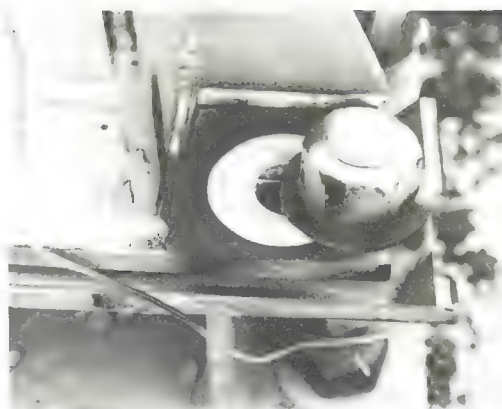
Figure 26. Breakaway base movement at column C (Test I).

Following the test, it was observed that the upper plate of the breakaway base at column C (Fig. 26) had slipped approximately 2 in. in the direction of vehicle impact. However, the truss and structure remained erect.

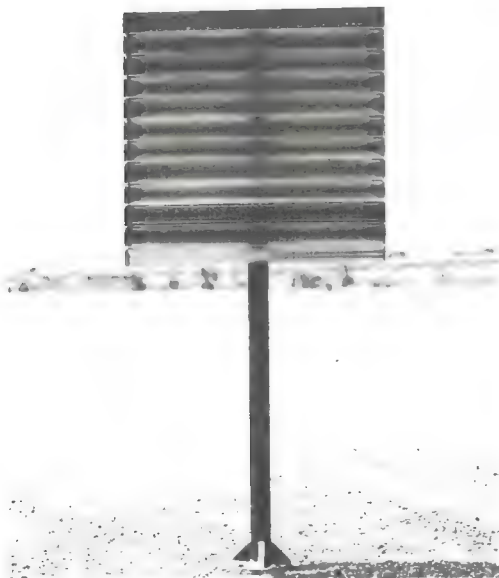
Figure 5. Curved-louver model no. 14.
